RETROFIT OF A STEEL-REINFORCED MSE WALL

Brian Hall, M.Eng., P.Eng., Alireza Afkhami, M.A.Sc., P.Eng.
Tetra Tech EBA, Vancouver, BC, Canada
Amri Benjamin, M.Eng.
Ledcor CMI Ltd., Edmonton, AB, Canada

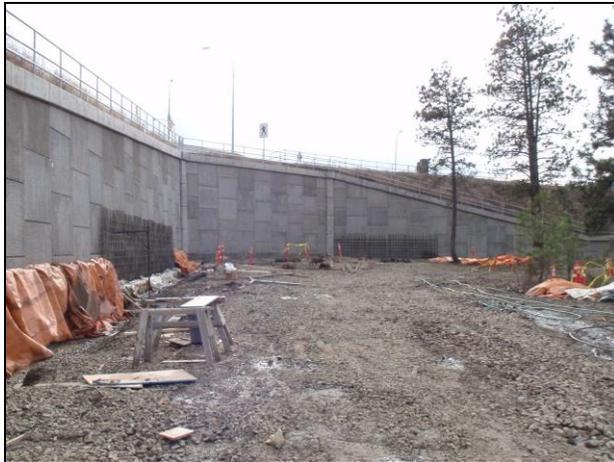
Figures 1 and 2 show a partial view and a typical cross section of the MSE wall. The wall supports a two lane section of roadway ramp, it is about 300 m long and has a maximum of 8 m high. The precast concrete facing panels are nominally 1.8 m by 1.5 m in size, and the MSE wall steel reinforcing (length approximately 70% of wall height)

Figure 1. MSE wall prior to retrofit.

- There was no evidence from visual observations or survey monitoring that, at the time the retrofit was undertaken, the wall was experiencing distress.

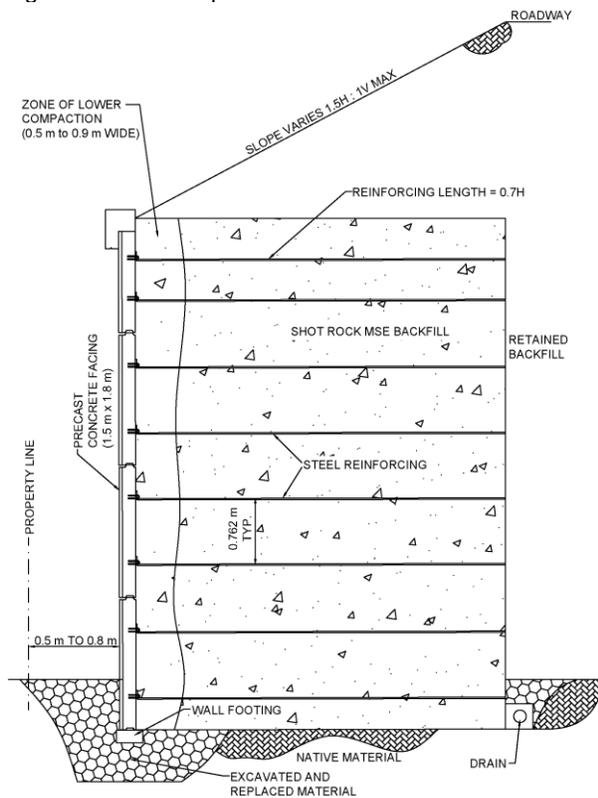
Figure 2. Typical section.

- The wall was located 0.5 m to 0.8 m from the property line so there was very limited space in front to accommodate permanent repairs (see Figure 2). However, a temporary construction easement to allow the retrofit to be constructed was negotiated.

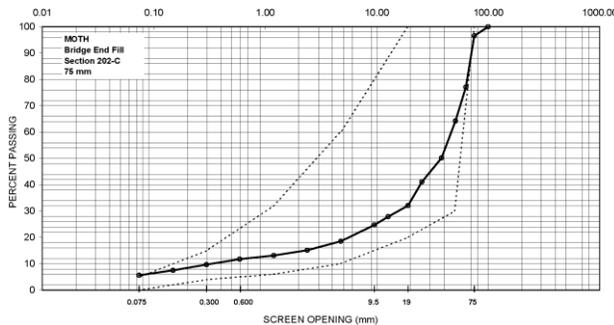
The MSE backfill consisted of owner-supplied crushed basalt shot rock from a stockpile adjacent to the work site. The backfill gradations (see Figure 3) were in accordance with BC Ministry of Transportation and Infrastructure Standard Specifications for Highway Construction (2009) Bridge End Fill (BEF), but tended to be on the coarse side of the specified grading envelope. The fines content (percent passing the 0.075 mm sieve) was variable and up to 8%. The percentage retained on the 19 mm sieve was typically between 40% and 70%. Because the fraction of material retained on the 19 mm sieve was greater than 30% compaction control could not be referenced to the familiar Standard Proctor moisture-density test (ASTM D698).

Figure 3. Typical MSE backfill gradation.

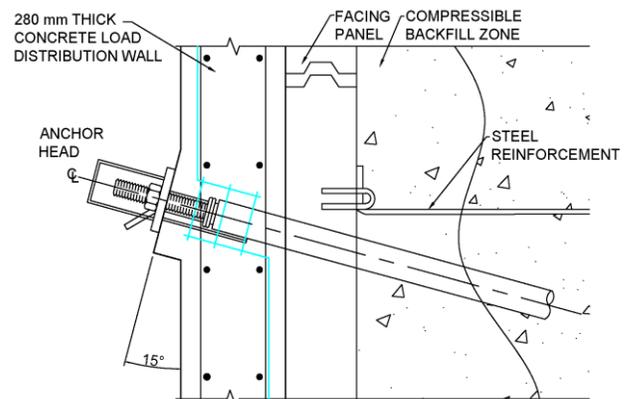
Figure 4. Typical anchor head and concrete blister section.

In order to distribute the anchor loads evenly and reduce the risk of differential movement between the facing panels, a 280 mm thick concrete load distribution wall (1.5 m and 3 m in height) was designed for the entire length of the lower portion of the wall (see Figure 4). The structural engineer further required helical piles be installed under the load distribution concrete wall due to the concern that the vertical component of the anchor load plus the weight of the concrete wall would damage the facing panels and open the joints between adjacent panels.

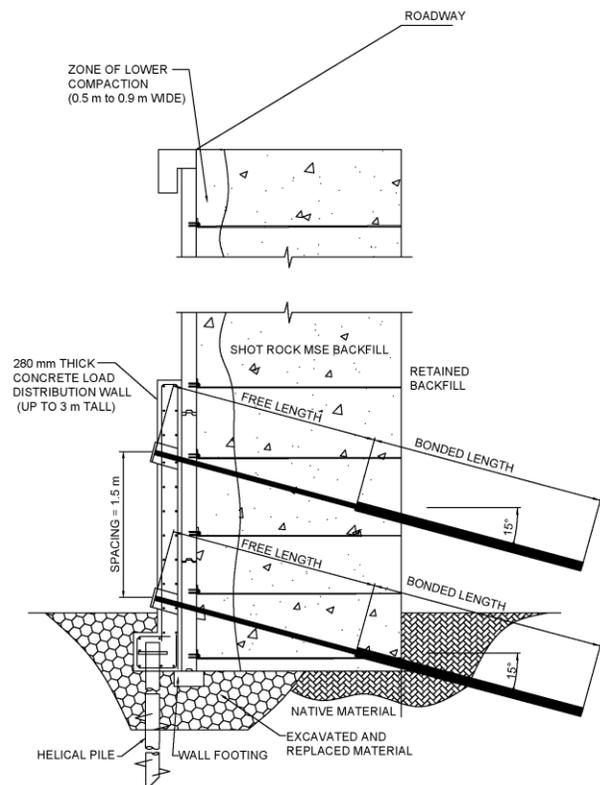
Figure 5. Typical retrofit design.

Figure 5 shows the typical retrofit design used for the subject MSE wall.

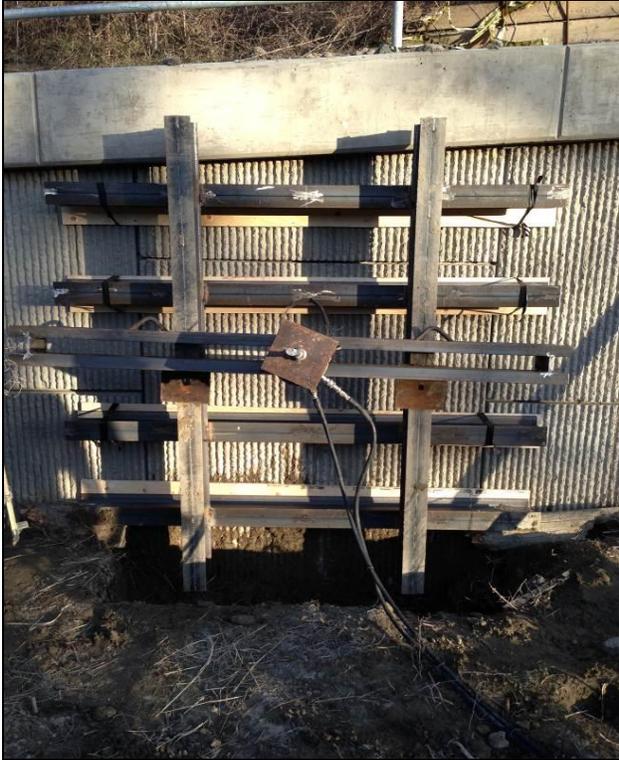
These tests did not reach failure but did indicate that the ultimate bond stress was in excess of 150 kPa with maximum 6 to 7 mm displacement (see Figures 6 and 7) being recorded.

Figure 6. Pull-out test on a sacrificial anchor installed in the MSE backfill zone.

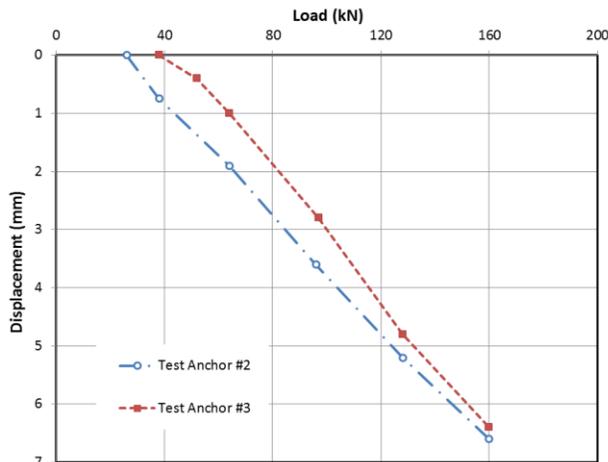
Figure 7. Load-deflection plot for bond stress verification anchors (133 mm diameter hole, 2.5 m bond length).

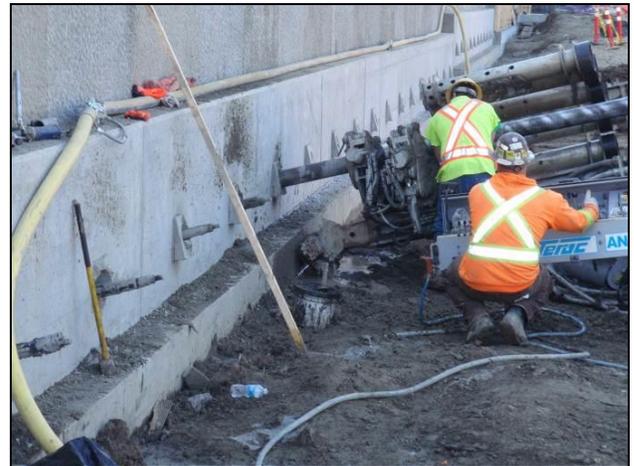
Figure 8. Drilling and soil anchor installation.

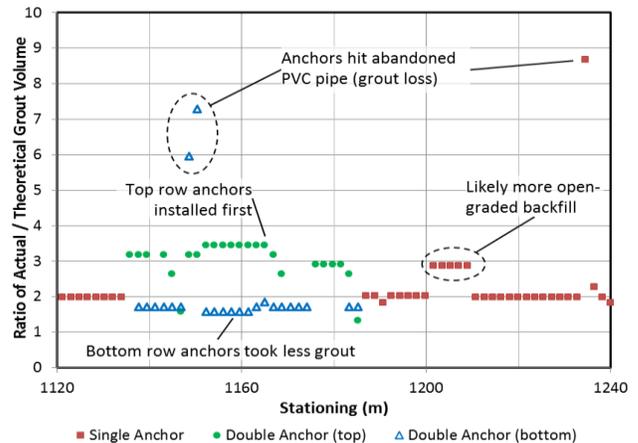
Figure 9 shows the ratio of actual/theoretical grout volume for bond length of the anchors. Typical section between Stations 1135 and 1185 consist of two anchors where the top row of anchors were installed first followed by the bottom row. As it can be seen in Figure 9, the bottom anchors took relatively less grout compared to the top anchors, which may be attributed to voids being partially grouted during installation of the top row of anchors.

In general, for sections consisting of two anchors the top row of anchors were installed first and the grout take within the bond length was around 3.5 to 4 times the net volume of the drill hole. The corresponding volume for the lower row anchors and for single anchor rows was generally between 1.5 to 2 times the theoretical volume.

Figure 9. Ratio of actual/theoretical grout volume for the bond length of the anchors.

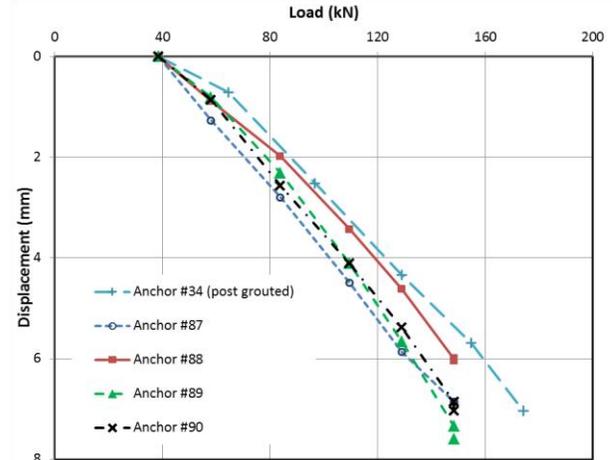
Proof testing was completed on all anchors that did not undergo creep or performance testing. Proof testing consisted of incrementally increasing the load until the anchor was loaded to 133% of design load. This load was then held for 10 minutes and the movement of the anchor head was measured by two gauges. If movement was less than 1 mm during the 10 minute holding period, the anchor was considered to have passed the test. The total displacement of anchors under the maximum test load was generally between 5 to 8 mm (see Figure 10). The expected displacement based on the anchor configuration was between 5 to 13 mm.

Only one anchor failed the proof test. This anchor was post-grouted and successfully proof tested three days later.

Figure 10. Load-displacement plot for proof tests.

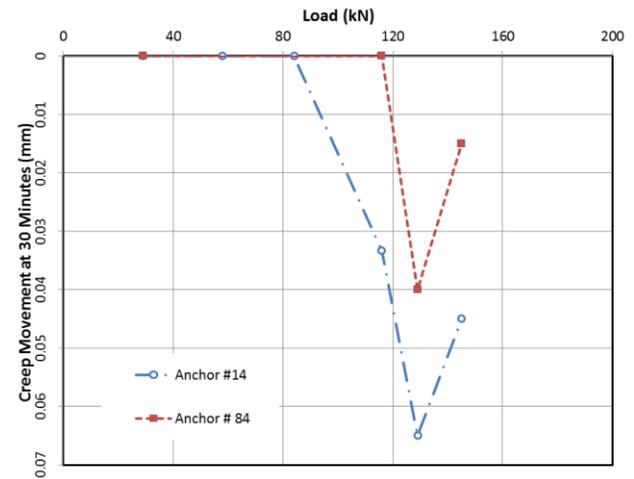
Performance testing was conducted by cyclically and incrementally loading and unloading the anchors to determine whether the anchor has sufficient resistance and if the apparent free length has been satisfactorily established. The magnitude of residual movement and rate of creep are shown in Figure 11.

Figure 11. Creep movement versus load measured for two anchors.

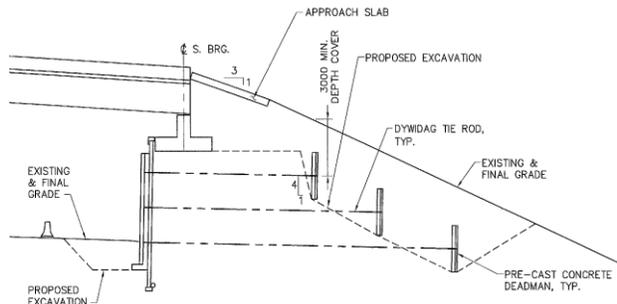
Figure 12. Typical detail of deadman installation for retrofit of a MSE abutment wall at wildlife crossing.

In one of the walls retrofitted there was insufficient backfill behind the wall to allow the use of soil anchors. In this case deadman anchors were installed (see Figure 12) by constructing walls behind the abutment and then drilling anchors through the walls to intersect the deadman which were then subsequently buried.
